# Team 81 Failure Investigation Report from the 2022 IREC

Worcester Polytechnic Institute High Power  
Rocketry Club, Worcester, MA, 01609, U.S.

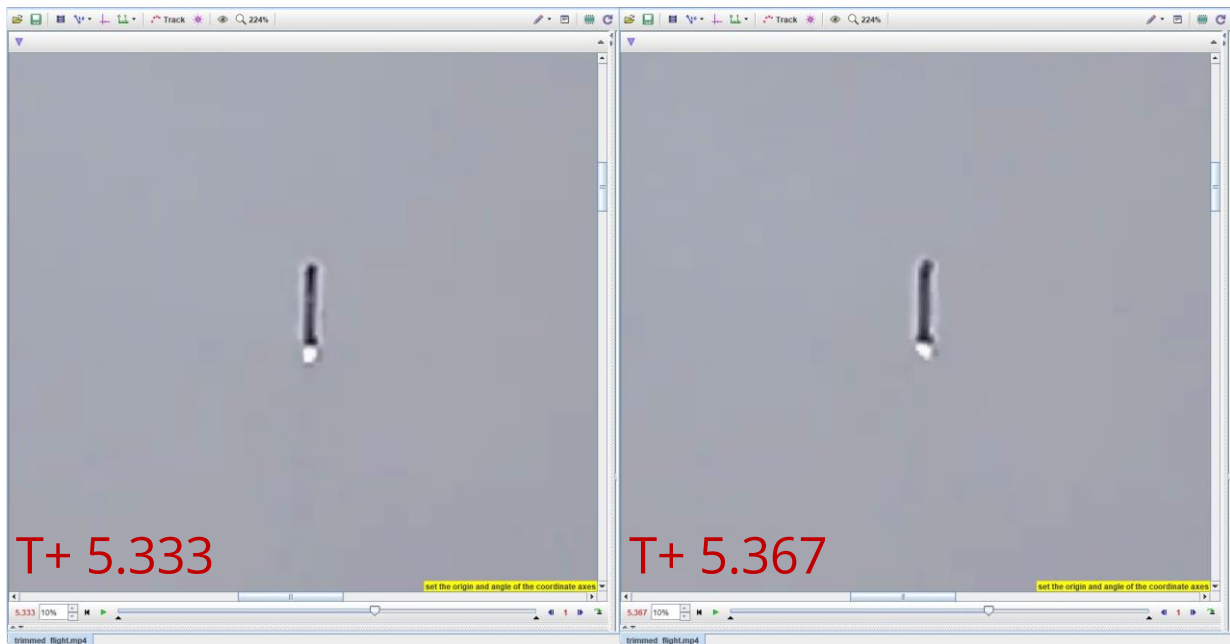
The vehicle successfully lifted off from pad 6 on bank A at 12:24pm MDT on Friday June 24<sup>th</sup>, 2022. At T+ 4.73 seconds, the exhaust from the motor began to visibly tail off, and the exhaust plume had nearly disappeared when, at T+ 5.37 seconds and an estimated altitude of 1960 ft, first movement of the nosecone is visible.

*Figure 4 First Movement of Nosecone*

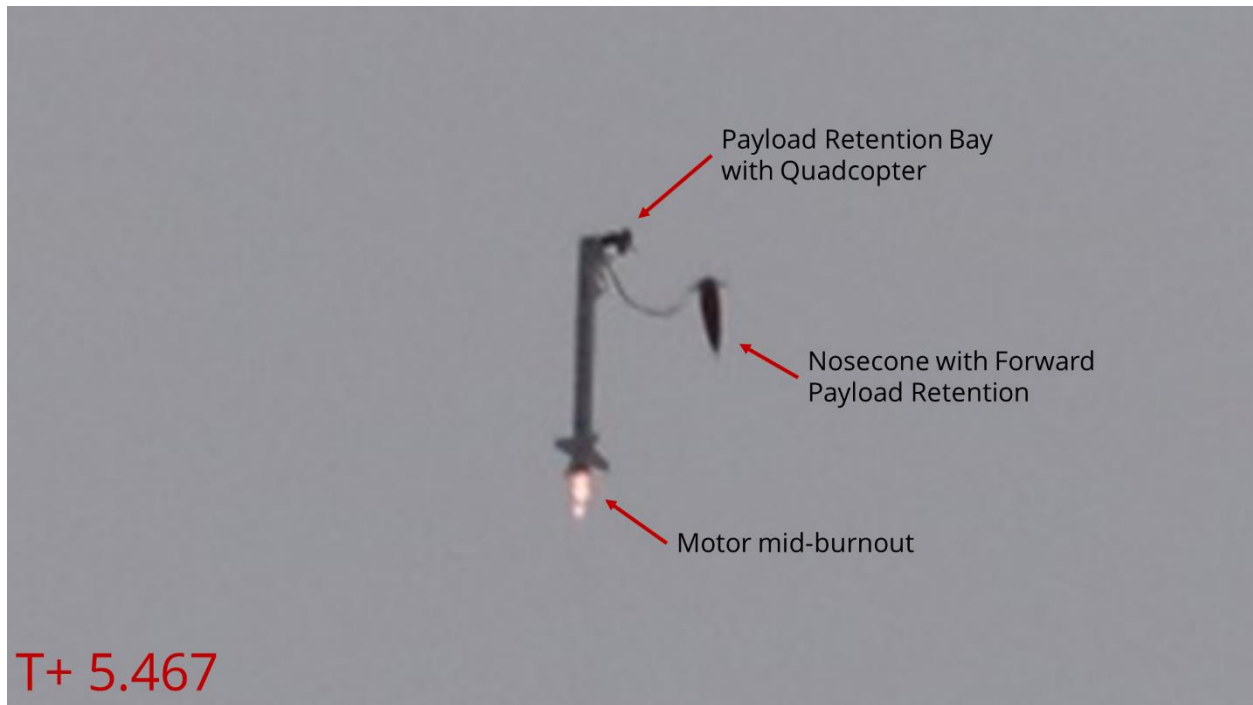
*Figure 5 T+ 5.467*

The nosecone proceeds to eject from the vehicle, followed by the payload. The nosecone is separated from the payload before the payload fully exits the bay at T+ 5.47 seconds.

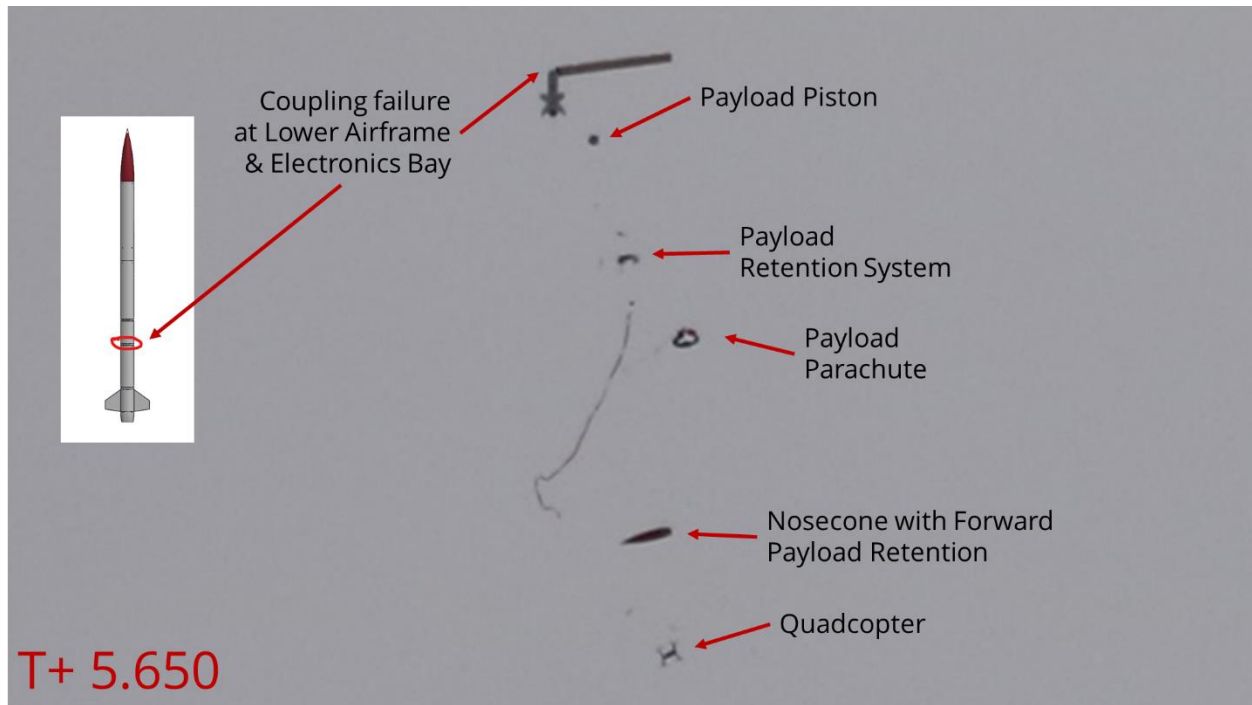
*Figure 6 T+ 5.650*

The payload retention system, parachute, and piston all continue to eject from the airframe. Due to aerodynamic forces caused by the payload exiting the airframe, the lower airframe coupling fails at T+ 5.50 seconds, causing the electronics bay, middle, and upper airframes to fall away from the lower airframe and fin can. The payload quadcopter also separates from the retention system.

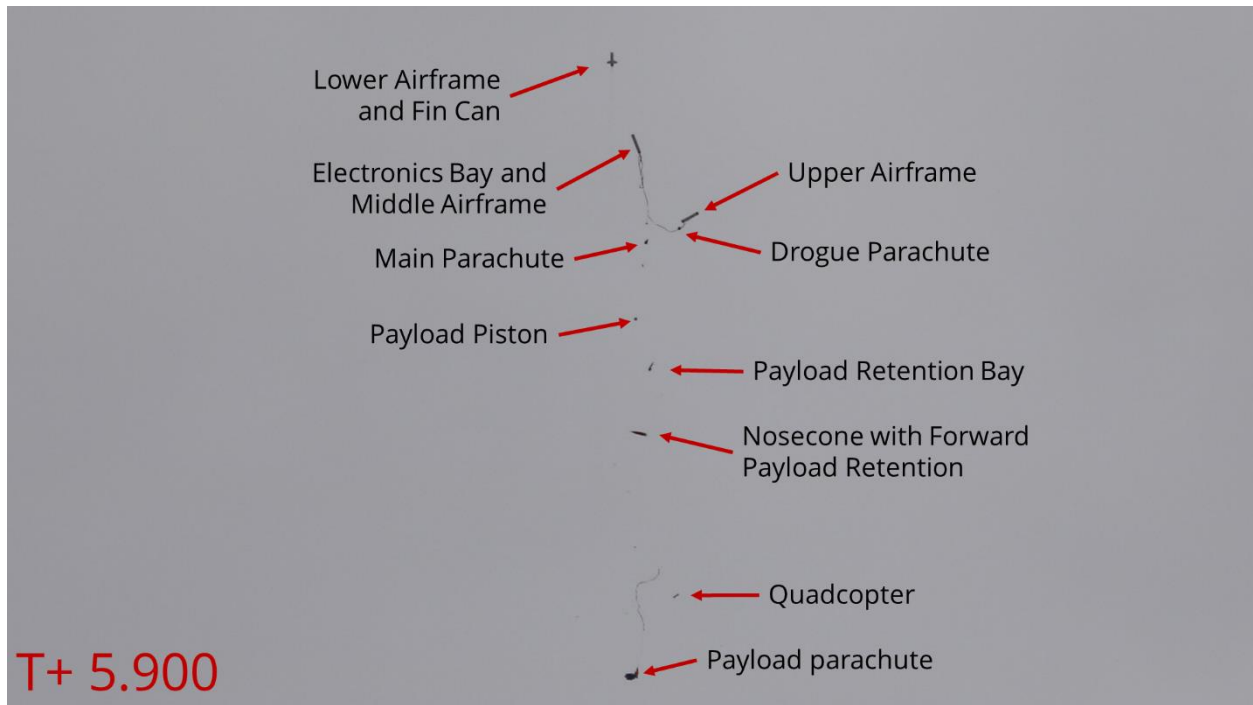
*Figure 7 T+ 5.900*

The upper and middle airframes separate at T+ 5.72 seconds, releasing the rocket recovery system consisting of the drogue and main parachutes, as well as all shock cord. All parachutes rip free of their shock cord or mounting points to the payload or airframe sections and fall freely. The lower airframe and fin can remain aerodynamically stable and continue to ascend.

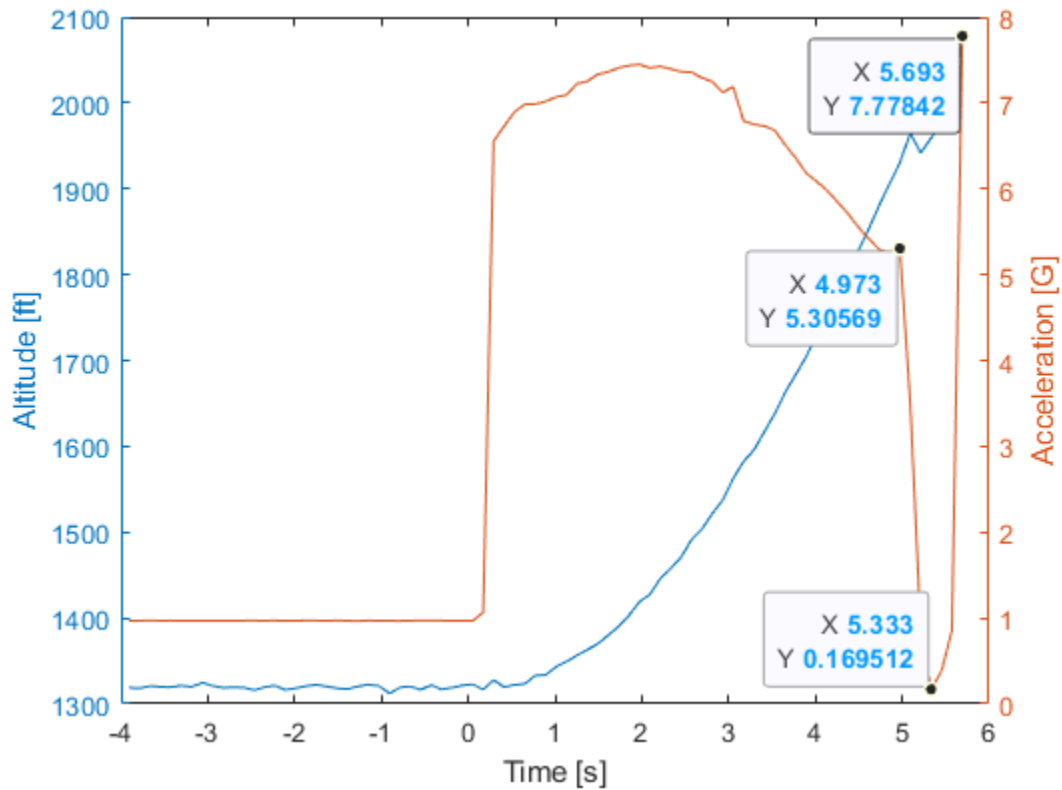
Telemetry received by the ground station confirms these series of events. Plotting the magnitude of the total acceleration, we see burnout take place at T+ 4.97 seconds, and the minimum acceleration where the vehicle is just experiencing drag at T+ 5.33 seconds, just before nosecone separation per the pictures. Then the acceleration spikes back up as the drag increases due to breakup, before data is lost. It should be noted that despite the exact matchup between the T+ 5.333 second event in Figure 4 and Figure 8, the liftoff times were reached independently. The acceleration data was not used to reconstruct liftoff time for the photos/videos or vice versa. However, that the data matches up so well is encouraging.

Figure 8 Altitude and Total Acceleration Data from Flight

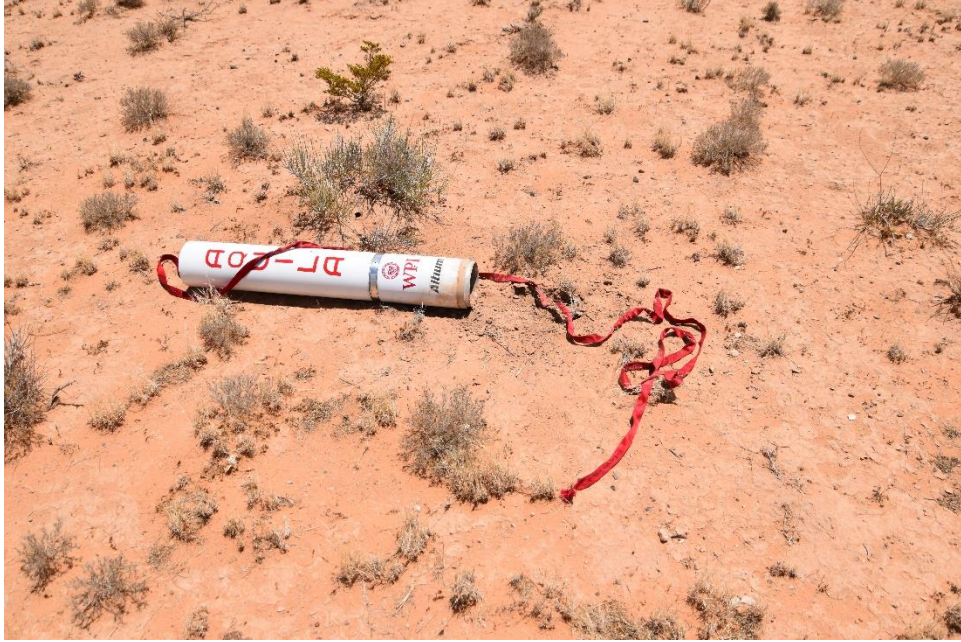
The major events of the failure occurred over 0.35 seconds, from T+ 5.37 to T+ 5.72. The airframe sections and payload components then fell ballistically due to the parachutes breaking free from all major sections. The electronics bay and middle airframe, upper airframe, nosecone, and quadcopter were recovered without significant additional damage due to ground impact.

*Figure 9 Middle Airframe and Electronics Bay*

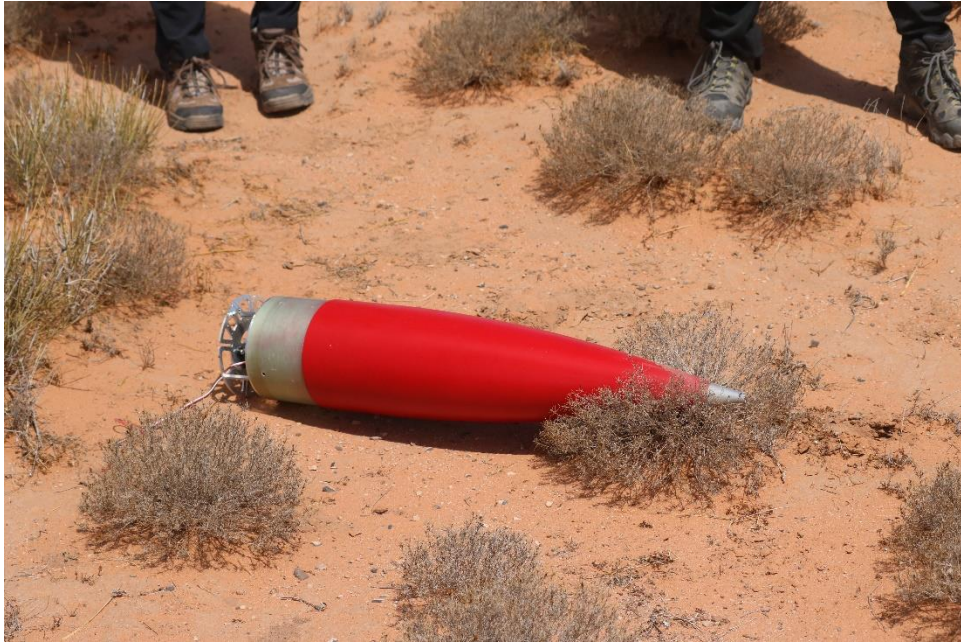
*Figure 10 Nosecone*

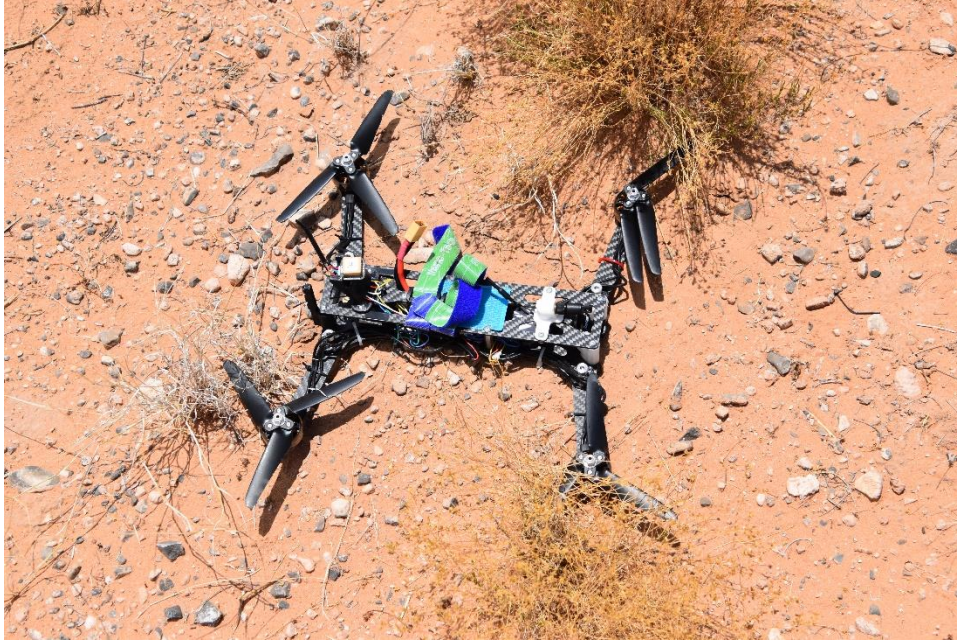
*Figure 11 Quadcopter*

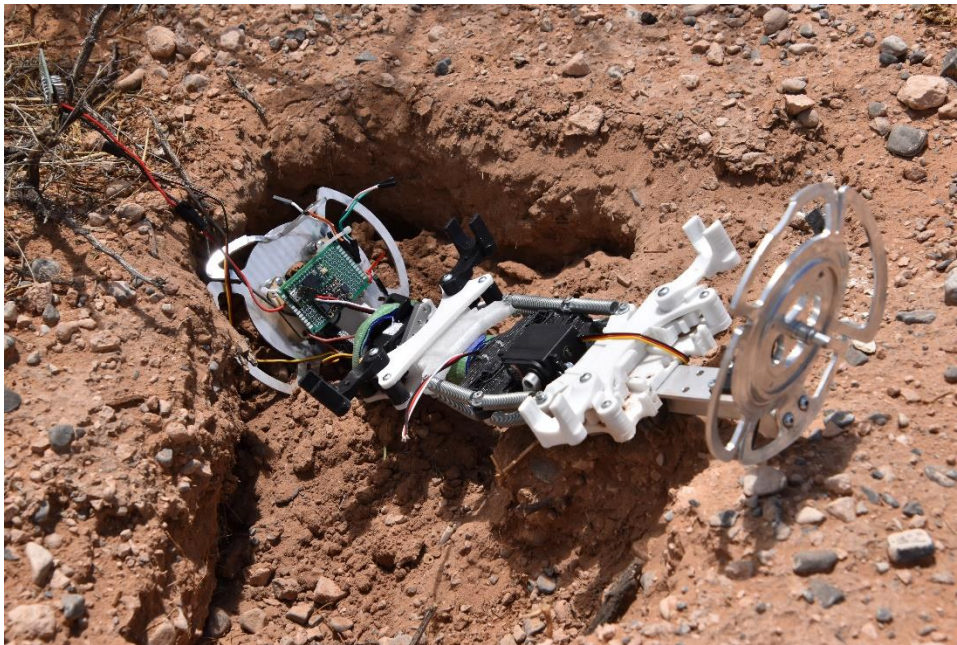
The payload retention system sustained more significant damage, landing in a small divot and bending the bulkhead and spine.

*Figure 12 Payload Retention System*

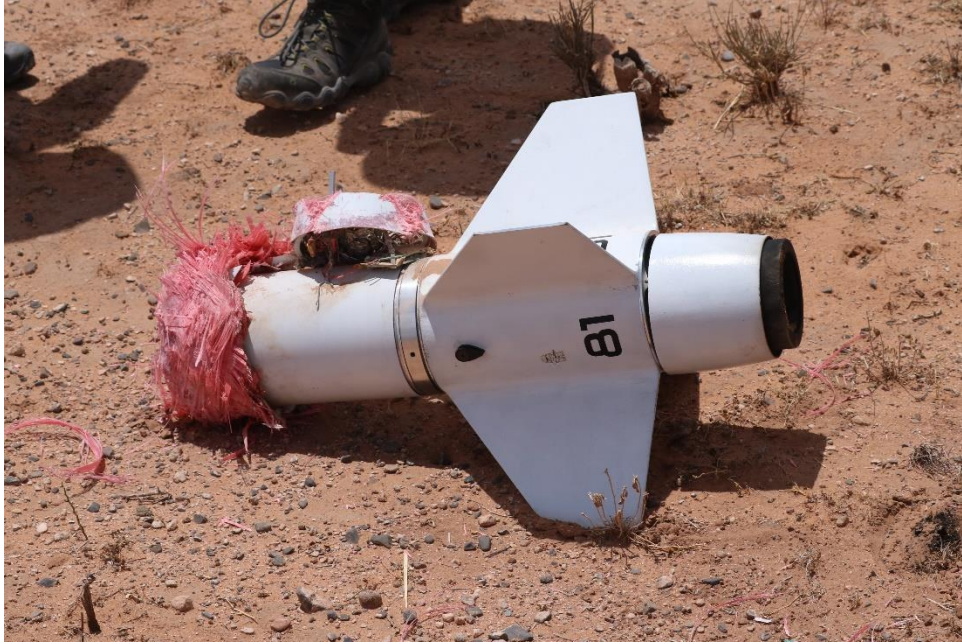
The lower airframe and fin can remained aerodynamically stable and impacted the ground with significant velocity. The impact shredded the forward section of the lower airframe, deformed the airbrakes around the forward closure, and buckled the motor casing.

*Figure 13 Lower Airframe and Fin Can*

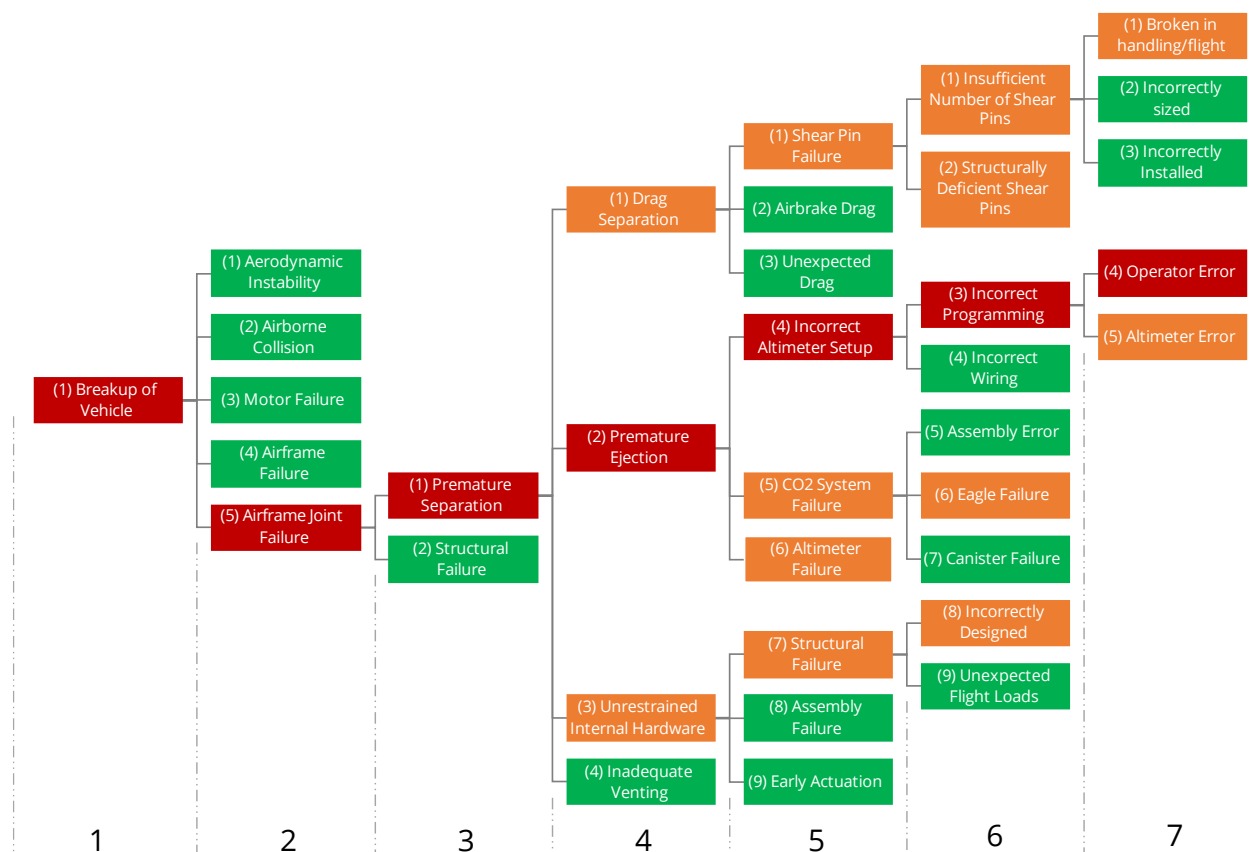
Figure 14 Failure Tree Diagram

A failure tree is one method used to identify the root cause of a failure. Construction of the failure tree begins with identifying the result of the failure, in this case the breakup of the vehicle. Each subsequent level of the tree describes direct causes of the result listed in the prior level. Items are categorized into three colors. **Green** indicates that the cause is closed, meaning that it was determined to not have occurred or to not have caused the failure. **Orange** indicates that the cause is unlikely, meaning that the investigation was unable to conclusively rule out this cause, but there is no significant supporting evidence or other reason to think the cause occurred. **Red** indicates the cause is open, meaning it has significant evidence in support of its occurrence and would cause the failures observed. Each level and cause in the failure tree are categorized with a number for easy identification.

The failure tree identifies a clear failure path, and some alternate failure modes that were possible, but unlikely. Each of the possible failure modes are discussed in more detail below

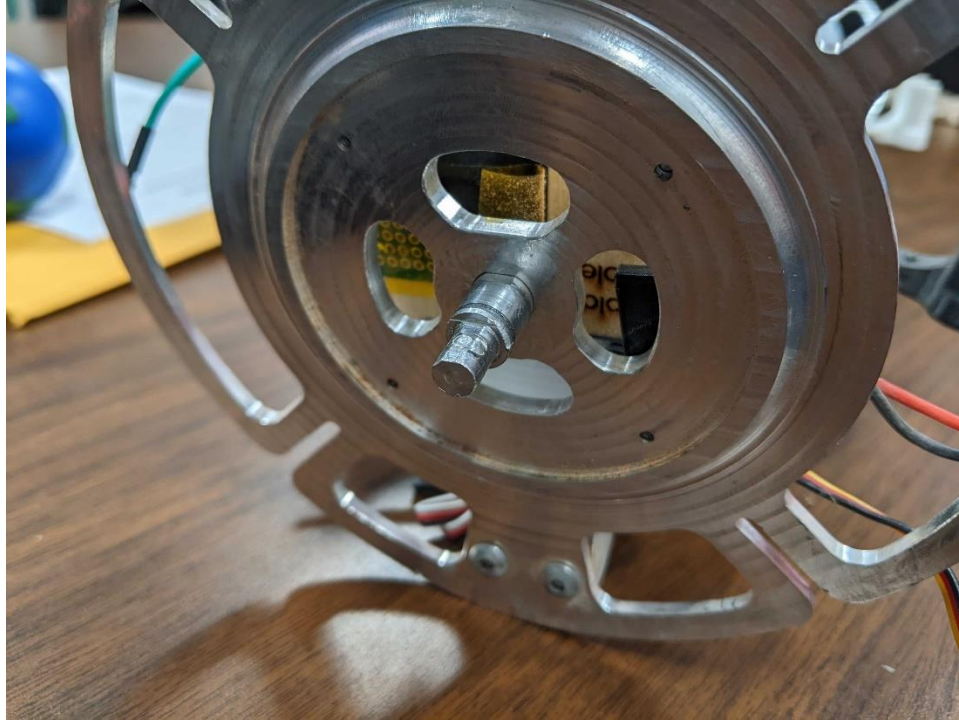
*Figure 15 Rotation Shaft of Payload Retention System*

Due to the weight of the section and the flight loads, it was theorized that the retention system could have broken away during boost, then its inertia could have carried it forward at burnout, impacting the nosecone with enough energy to cause the separation. This was a particular concern because retaining rings are rated for use with a shaft material harder than that of the ring. The aluminum 6061-T6 shaft is significantly softer than the 1060 steel retaining ring used.

To determine if the retaining ring was likely to have failed due to flight loads, a more detailed analysis of retaining ring loads was conducted using standard equations [3]. The constraining failure mode was determined to be due to groove deformation, with a theoretical load capacity of 541 lb (2406 N). The vehicle experienced a maximum acceleration of 7.5G during boost. The mass of the unrestrained section was around 5 lb, meaning the retaining ring would experience a maximum thrust load of 37.5 lbf (167 N).

While this analysis shows significant margin for failure due to thrust loads, it is possible that manufacturing inaccuracies could have resulted in a mis-sized groove, a chamfer, or other weakening feature so the failure mode could not be entirely ruled out. Additionally, when investigating the rotation shaft, some question was raised as to if the shaft would have survived the bending loads experienced during recovery. These bending loads were not present during flight as the payload assembly was contained within the airframe, but due to the parachute attachment location on the payload the shaft could have sustained significant additional loads that were not analyzed.

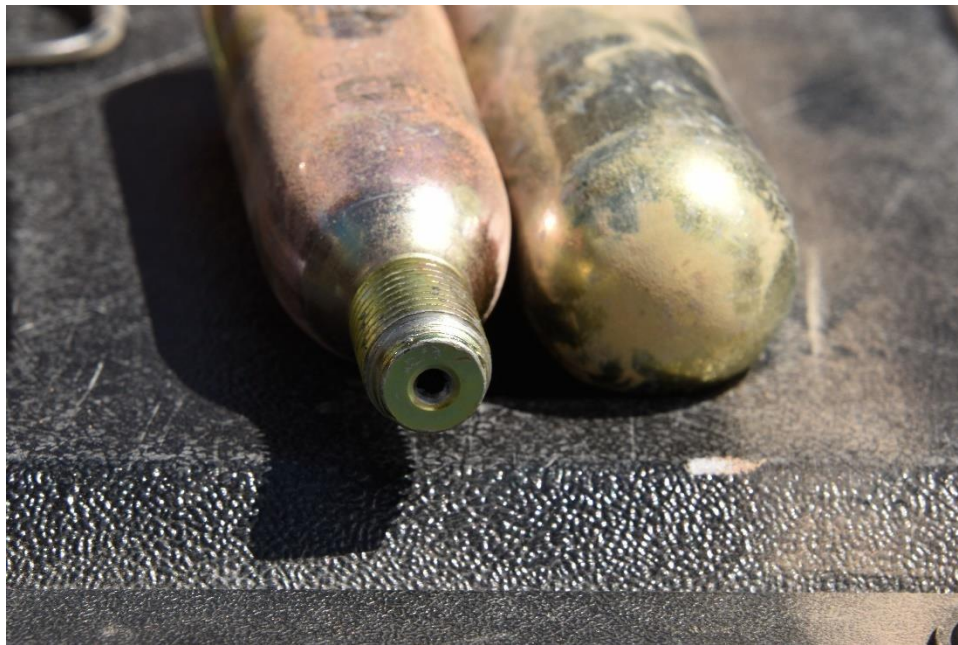
It is also possible that the CO<sub>2</sub> system itself failed, puncturing the CO<sub>2</sub> canister without the e-match firing. This could happen due to unexpected flight loads, or mechanical failure. However, no unexpected loads were noted in the accelerometer data, and no obvious damage was present after disassembling the CO<sub>2</sub> systems. Again, these systems are commercial products, with many successful flights with more challenging dynamic environments, so it is unlikely that the CO<sub>2</sub> system itself failed. It is also possible that the CO<sub>2</sub> canister itself failed, however visual inspection of the canisters indicated a puncture hole consistent with those caused by the puncture piston of the CO<sub>2</sub> system, so this failure mode was ruled out.

*Figure 16 CO<sub>2</sub> Canister Post-Flight*

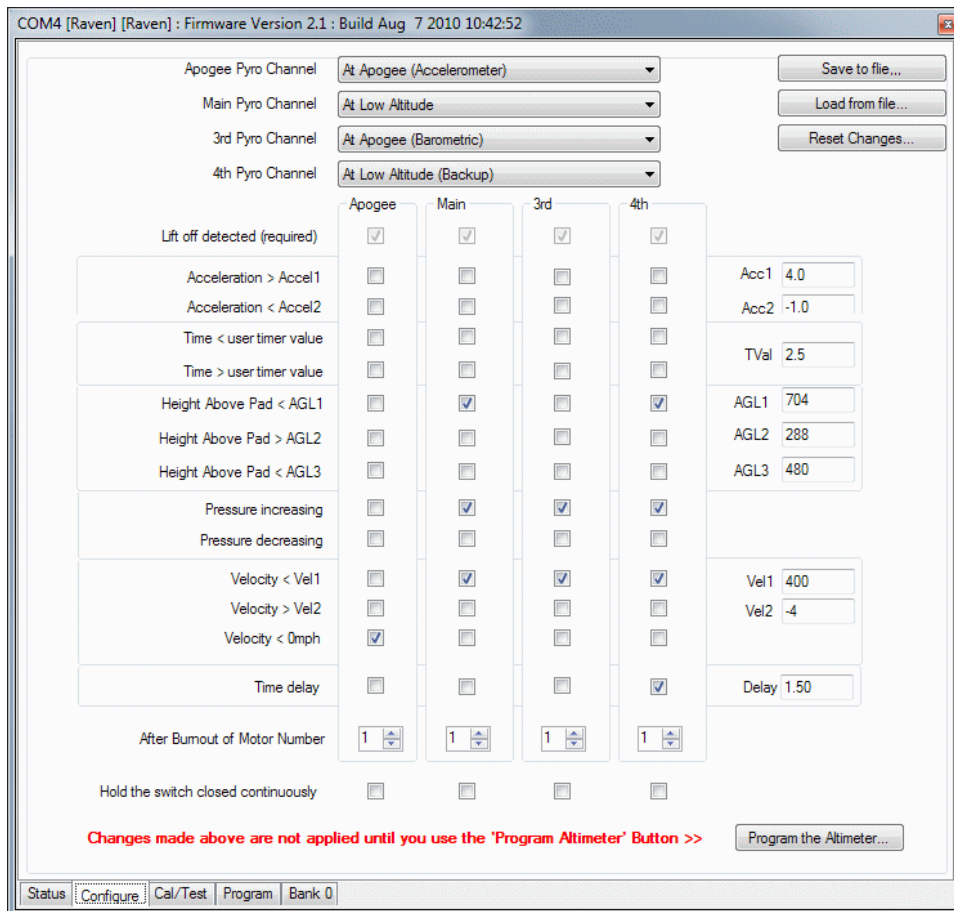
Figure 17 Example of FIP Interface

The incorrect configuration could have been loaded on the altimeter due to a failure with the altimeter itself. To program the altimeter, the user enters the configuration using software provided by the manufacturer, then loads that configuration onto the altimeter. If the altimeter does not accept the programming, there may not be any indication to the user. This failure mode was deemed extremely unlikely, as the altimeters are commercial devices and are known to be extremely reliable.

The most likely cause of the failure therefore is incorrect programming by the user. WPI HPRC follows a set of checklists during the setup and launch of the vehicle. One of the points on these checklists is to verify the payload altimeter settings prior to installation of the payload into the vehicle. During launch day, the altimeter settings for both the payload and rocket altimeters were presented for verification to the rocket division lead, and several issues were noted with the configuration of the altimeters. These issues were communicated to the member programming the altimeters, and the member was tasked with fixing the issues per the rocket division lead's verbal instructions. The member made, or believed they had made, the requested changes, and then the payload was integrated into the vehicle. At no point prior to integration were the settings reverified by any responsible parties. At this time, multiple events were occurring at once, and with only one checklist available the assembly of the vehicle proceeded without the proper signoff. Subsequently, the safety officer requested that the rocket lead verify that multiple checklist items relating to the recovery system had taken place, which the rocket lead confirmed. Among these items was the verification of the altimeter configuration.

#	Recommendation	Justification
6	Verify COTS avionics programming by reading the data with a separate computer than the one it was programmed with.	<p>From the point where the user presses “program”, the operation of an altimeter, GPS unit, or other COTS avionics system becomes a black box. While most programs will report a “success” or “failure”, there is no guarantee that the programming was loaded correctly.</p> <p>While failure to accept programming is unlikely, and was not the cause of this failure, verification with an independent system would provide an extra layer of security, both to hardware/software failure, and to human error by requiring the involvement of a second individual to verify this critical information.</p>
7	Host more rigorous and regular inter-division design reviews	<p>WPI HPRC consists of multiple divisions that work together throughout the year to develop our competition vehicle. The payload division works mostly independently of the rocket division, which is helpful, if not necessary from a management perspective, but also can contribute to poor communication and knowledge gaps.</p> <p>A rocket division member, more familiar with the loads and dynamics of recovery and landing under parachute may have identified the weakness in the rotation mechanism of the payload retention system. While this did not contribute to the failure this year, it is not difficult to imagine situations where expertise from one division would benefit the other. More regular inter-division reviews would increase the chances of identifying possible design issues and failure modes.</p>
